Subject: Docket No. 50-482: Licensee Event Report 2008-004-01, Loss of
Power Event When the Reactor was Defueled

LICENSEE EVENT REPORT (LER)

4. TITLE
Loss of Offsite Power Event When the Reactor Was De-fueled

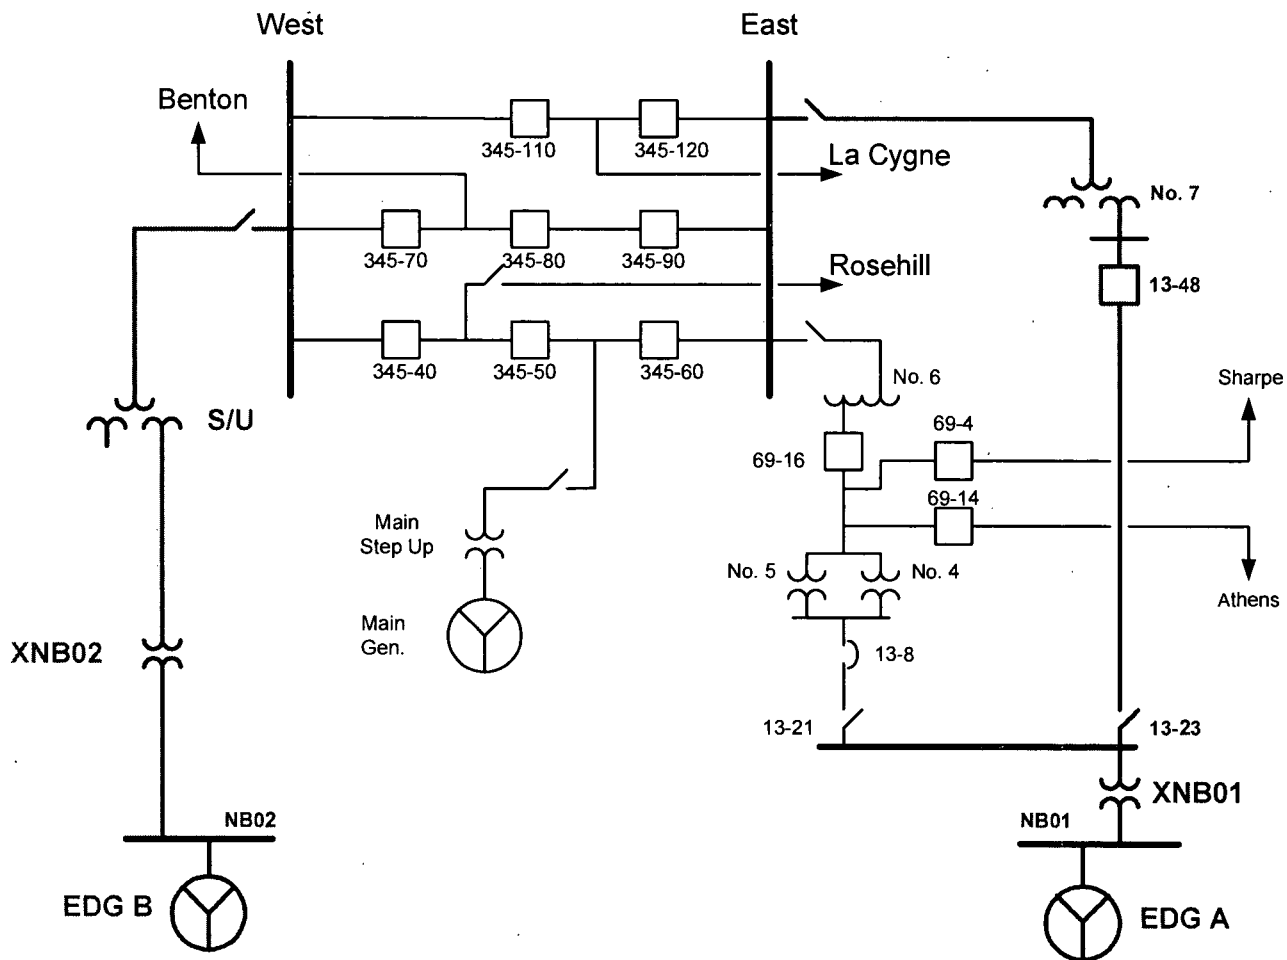
ONE LINE DIAGRAM

(Refer to Diagram on page 5 of 5)

one of WCGS owner companies, closed the wrong set of trip links on a 345 kV breaker during the Rose Hill transmission line transfer/breaker failure trip preventative maintenance (PM) testing. Instead of closing the Rose Hill transmission line trip links, the technician closed the Plant Startup (PSU) primary and backup trip links, which are associated to the WCGS startup transformer protection. When the links were closed, the breaker failure circuitry associated to the startup transformer was enabled. With the incorrect links in service and when the manual trip signal was generated as a part of the PM activity, the remaining off-site power connections to the West 345 kV bus were de-energized by the opening of their associated breakers. This inadvertent action tripped the West 345 kV bus and caused the LOOP.

The cause of the LOOP was initiated by a human performance error. A Westar Senior Relay Technician inadvertently closed the wrong set of failure trip links (Plant Startup (PSU) breaker failure links) on a Switchyard breaker during the Rose Hill transmission line transfer/breaker failure trip testing PM activities.

Revisions to procedure AP 21C-001, "WCGS/Westar Substation," were completed to provide for improved interface during work activities in the switchyard. Procedure revisions made included the following:

- Requirement for direct oversight of critical work activities.
- Requirement for a designated WCNOG person as the Switchyard Coordinator for liaison between Westar and WCNOG.
- Requirement for Westar work orders/instructions that involve WCGS switchyard work activities contain sufficient and specific details for successful completion of the work activity.
